School District of Lancaster Green Roof Assessment

By request of the School District of Lancaster and LIVE Green Lancaster, Green Roof Technology has toured and evaluated three green roofs in the district. The general diagnosis of the health of the green roofs is poor, a D+ average. It is our opinion that neglect of maintenance duties, coupled with key structural deficiencies, has led to a deterioration of the general health of the ecosystem. Green roofs are a living system that require due diligence in order to reap their myriad rewards.

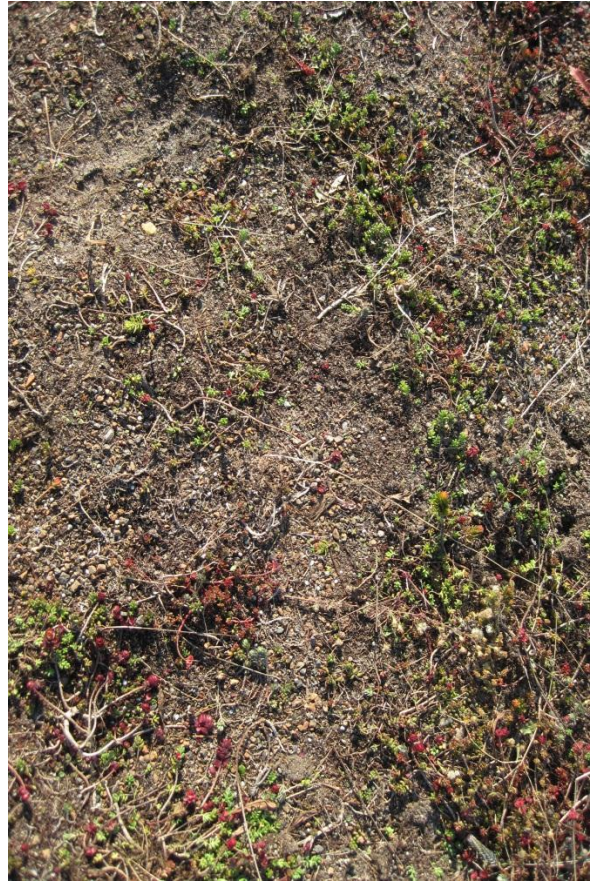
Bare media leads to erosion, poor storm water management and increased weed susceptibility. It is worth noting that this picture was taken post intensive weeding. Such extreme measures lead to compacted soil which causes poor sedum growth and increased susceptibility to unwanted plants.

Lack of any maintenance has resulted in aggressive weed growth and substantial sedum die back. Over two-thirds of the roof is exposed to day-long full sun and media exposure in this area is in excess of 50 percent.

Immediate maintenance is required. A coordinated maintenance schedule is necessary between a maintenance team and a green roof professional. Professional oversight is required to monitor progress and actively evaluate the health of the roof.

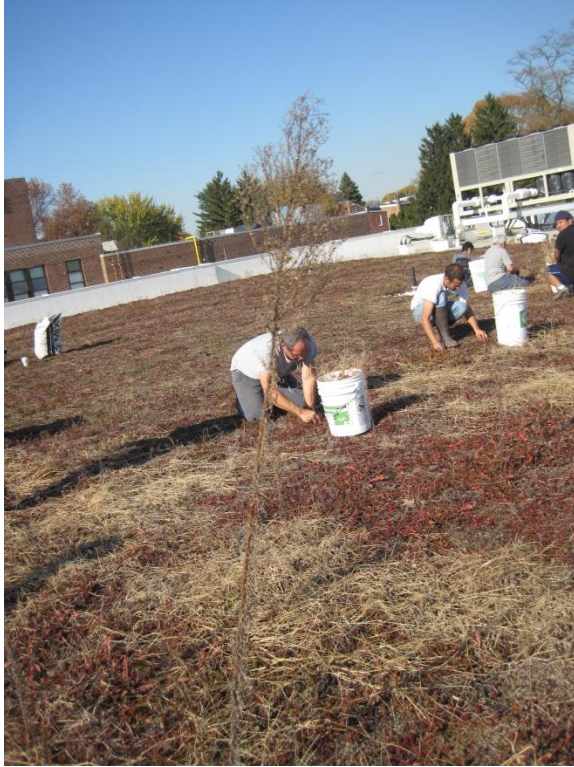
Dense layers of dead grasses create a suffocating blanket of biomass over the sedums.

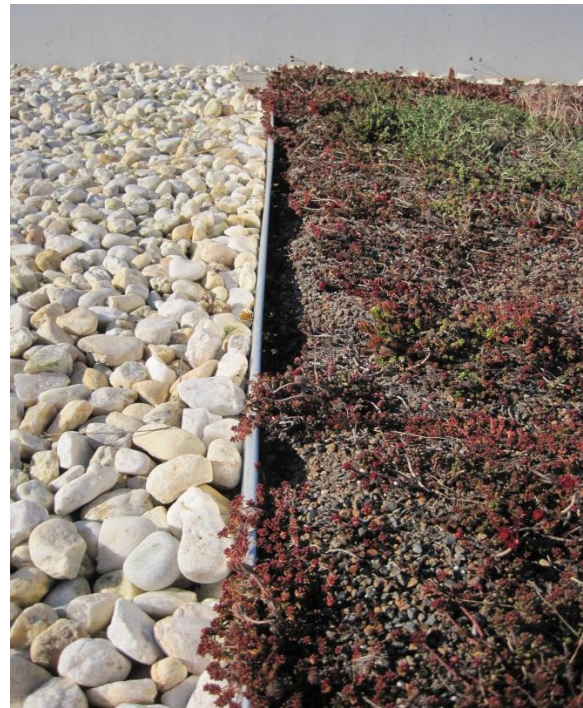
Erosion is caused by the poor structural quality of the modular system. Wind erosion is also prevalent throughout the roof due to sedum die back.

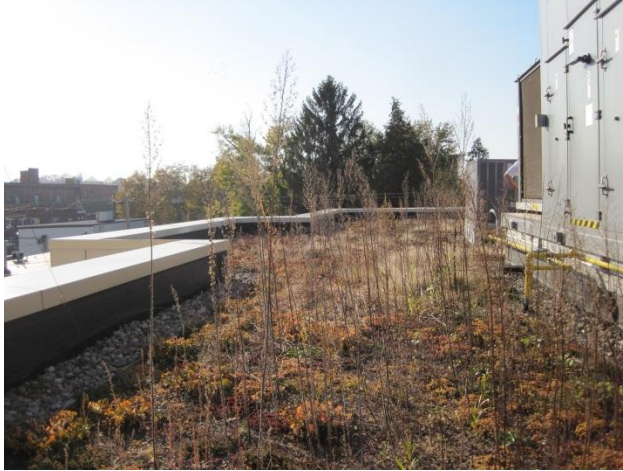
Tall weeds are firmly established and dominate the landscape.

Immediate maintenance is required. A coordinated maintenance schedule is necessary between a maintenance team and a green roof professional. Professional oversight is required to monitor progress and actively evaluate the health of the roof.

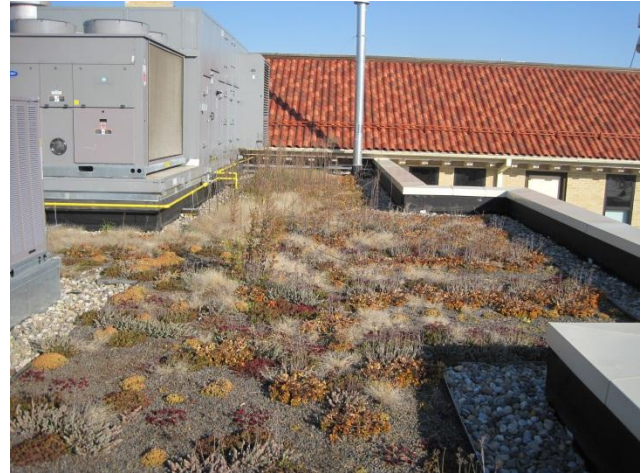
The sedums have achieved very modest growth, appear malnourished and are often still isolated in clumps. A poor growing media is a likely culprit. The lack of maintenance has caused die back in areas due to weed competition. Sedum growth is occurring along water sealed edges of roof access points. Root penetration in these areas can lead to leaks and water damage.

Large areas of exposed media are due to poor sedum growth as a result of the inadequate growing media quality.

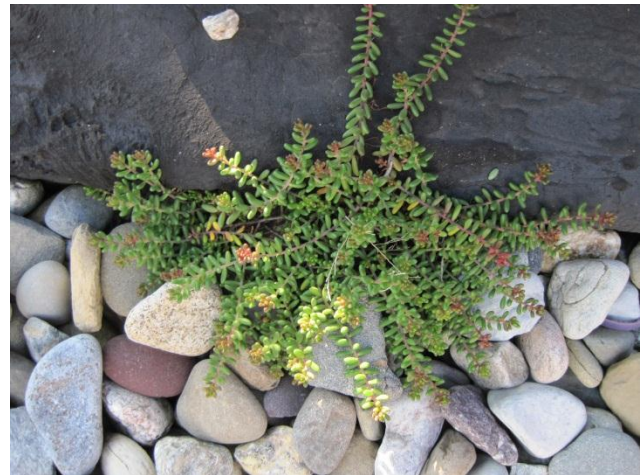
A sedum has firmly established itself in the waterproofing surrounding the roof access point. This is a common cause of water leaks.

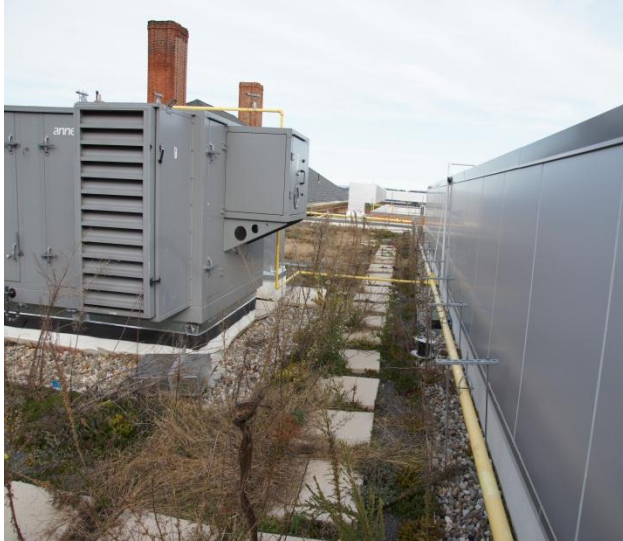
The eastern side of the roof. Trade winds carry the weed seeds up from the ground.

Again, maintenance is an issue concerning the general health of the green roof. Weed seeds have been carried by trade winds onto the roof and have established heavily along the eastern side of the roof. The roof slopes towards the eastern side, so weeds have thrived on the extra available moisture.

Immediate maintenance is required. The drainage area must be cleaned and rebuilt by a green roof professional soon before the snows arrive and subsequent melts occurs.

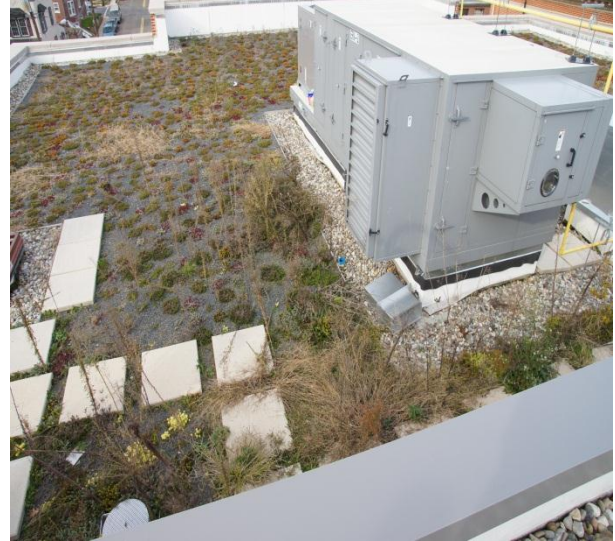
The western side of the roof is nearly weed free. The high eastern parapit captures the seeds.

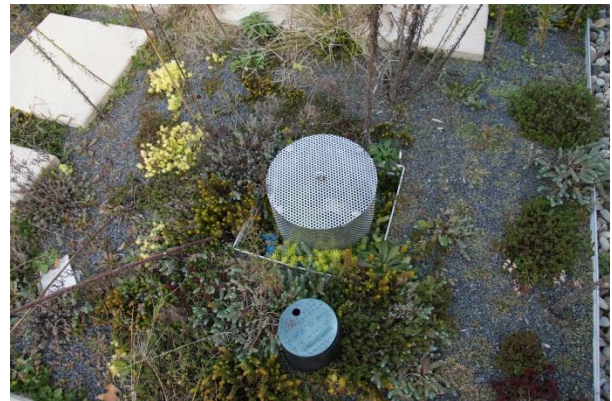
Another big cause for concern is the drainage system. Sedums have over-run the poorly designed drain leading to potential blockages and water damage.

Excess moisture is being trapped in the poor media surrounding the drain, which has led to sedum infestation and high blockage potential.

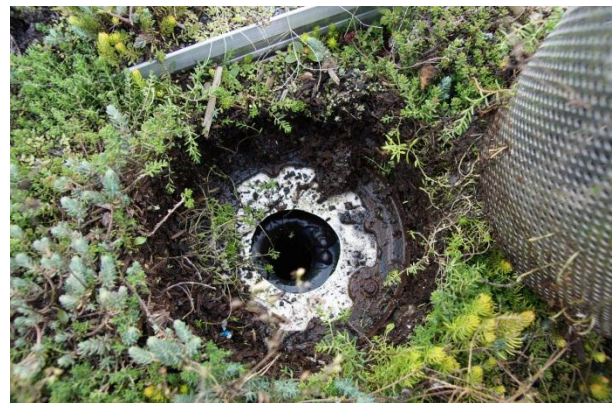
Removing the drainage grate reveals the extent of the problem. This area should be extremely well draining and most often dry.
